### Performance of Buildings in the Haiti Earthquake

A report by Members of the Earthquake Engineering Research Institute Reconnaissance Team

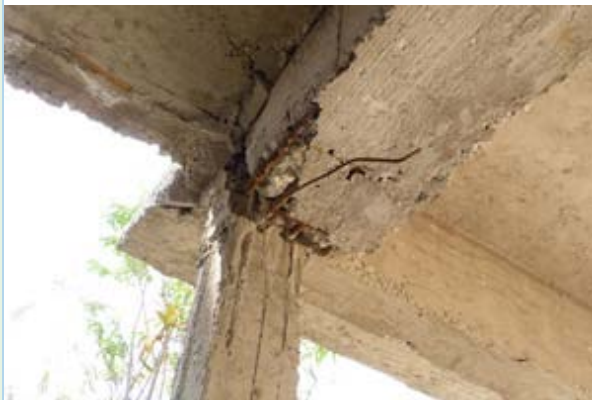
An example of poor coverage and lapping of reinforcing steel at column to beam from a building in Haiti after the earthquake. Photo by Martin Hammer.

The lack of adequate seismic detailing is pervasive in Haiti. Use of undersized and insufficient amounts of longitudinal reinforcement is very common in most columns, typically with a longitudinal reinforcement ratio of 0.4-0.8 percent. In addition, transverse reinforcement was frequently inadequate in size and spacing, and at times omitted altogether. We did not observe a decrease in lateral tie spacing at column ends in non-engineered structures.

suffered only minor damage from the quake. Built to standards referenced in the IBC and ACI-218, it stands essentially intact amid surrounding structures that collapsed. Compare that to the [photo at the top the previous page](#), demonstrating poor coverage and lapping of reinforcing steel at column to beam.

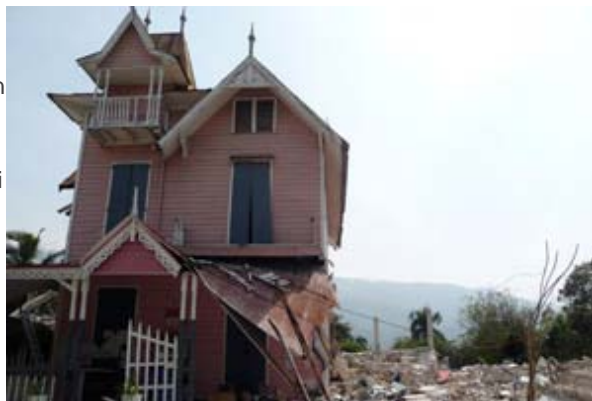
Wood frame building next to site of collapsed concrete building in Haiti. *Photo by Martin Hammer.*

Many of the timber frame buildings, though sometimes suffering from termite damage or poor

maintenance, performed quite well with their more flexible structural systems. It is common to see one of these structures standing next to a concrete and masonry building that collapsed.

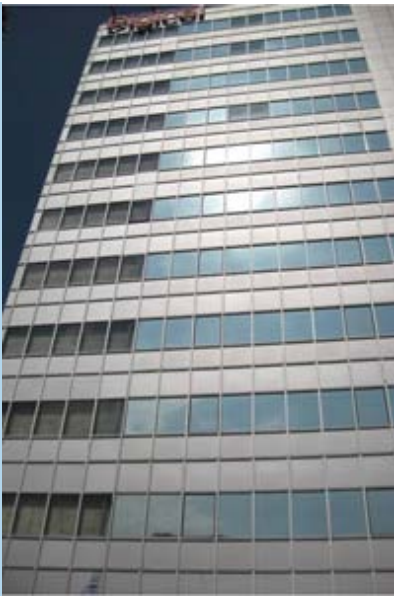
Digicel headquarters in Port-au-Prince, Haiti after the earthquake. The building suffered some very minor damage, but is essentially intact. *Photo by Dr. Reginald Desroches.*

One example of good performance is the case of the 12-story, reinforced-concrete frame Digicel headquarters building, which is the tallest building in Port-au-Prince. The building was detailed according to ACI-318 specifications, and such detailing appeared to have been adequate. The building sustained minor damage in the form of minor concrete spalling of columns and minimal nonstructural damage to partition walls, ceiling tiles, and the curtain wall.
