# Compartment Fire Testing of a Two-Story Mass Timber Building

General Technical Report  
FPL-GTR-247

Five full-scale fire experiments were conducted to observe the performance of a two-level apartment-style structure constructed of mass timber. Each level consisted of a one bedroom apartment, an L-shaped corridor, and a stairwell connecting the two levels. One of the primary variables considered in this test series was the amount and location of exposed mass timber. The amount of mass timber surface area protected by gypsum wallboard ranged from 100% to no protection. For each experiment, the fuel load was identical and the fire was initiated in a base cabinet in the kitchen. In the first three experiments, the fire reached flashover conditions, and subsequently underwent a cooling phase as the fuel load from combustible contents was consumed. The first three experiments were carried out for a duration of up to 4 h. In the fourth experiment, automatic fire sprinklers were installed. Sprinklers suppressed the fire automatically. In the fifth experiment, the activation of the automatic fire sprinklers was delayed by approximately 20 minutes beyond the sprinkler activation time in

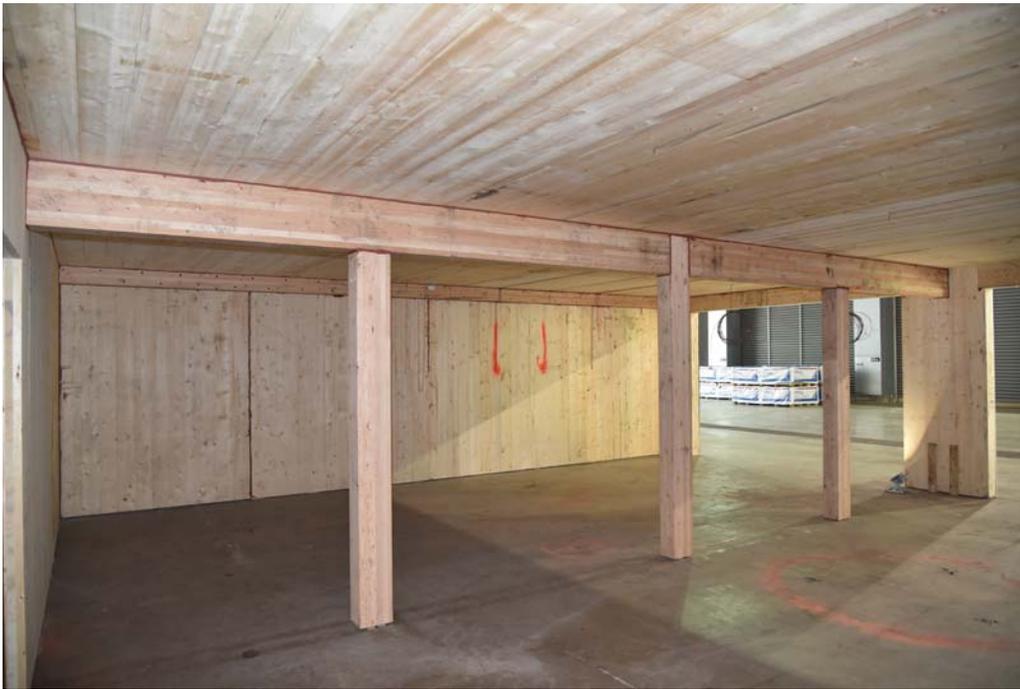
Figure 13. Original midspan beams and support columns on the first floor.

The second-level apartment floor was supported midspan with glulam beams and support columns (Fig. 13). The midspan beam consisted of nine-ply glulam timber and was

divided into two sections. Each section was approximately 4.46 m (14.7 ft) long, and the beam was 346 mm high by 171 mm wide (13-5/8 in. high by 6-3/4 in. wide). As illustrated in Figure 14, the first beam spanned from Wall A to the side of the middle support column and the second beam spanned from the side of the middle support column to Wall C. The three support columns consisted of six-ply glulam timber and were approximately 225 mm wide by 171 mm deep (8-7/8 in. wide by 6-3/4 in. deep). The middle column was 2.74 m (9 ft) tall, and the other two columns were approximately 2.41 m (7 ft 11 in.) tall. The seams and joints at connections between the beam and support columns were sealed with an intumescent firestop sealant (FS-One Max).

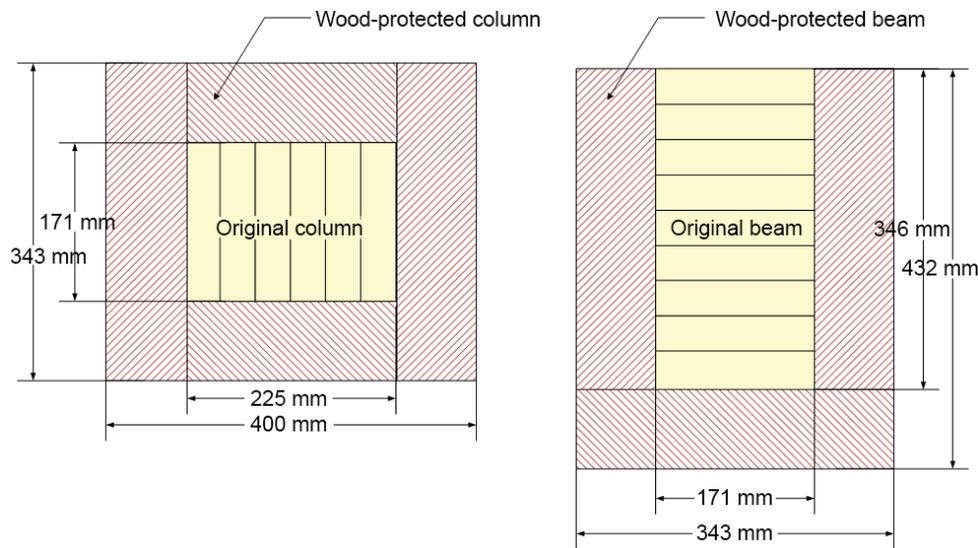
Figure 15. Cross-sectional view of a support column and midspan beam illustrating the wood protection added to achieve a 2-h fire resistance rating.

resistance rating, designed in accordance with Chapter 16 of the National Design Specification (NDS). Therefore, total depth of the beams on the first level was approximately 432 mm (17 in.) and total width was approximately 343 mm (13-1/2 in.). Support columns on the first level had a total width of approximately 400 mm (15-3/4 in.) and a depth of approximately 343 mm (13-1/2 in.). This additional wood protection was added to the beams and columns on the first level because they were exposed (that is, no gypsum wallboard protection) in Test 4 and Test 5. Figure 15 shows the wood protection added to the support columns and beams on the first level. Figure 16 shows the protected beams and support columns. Although not shown in Figure 16, the seams and joints formed by adding the additional material were sealed with an intumescent firestop sealant (FS-One Max).

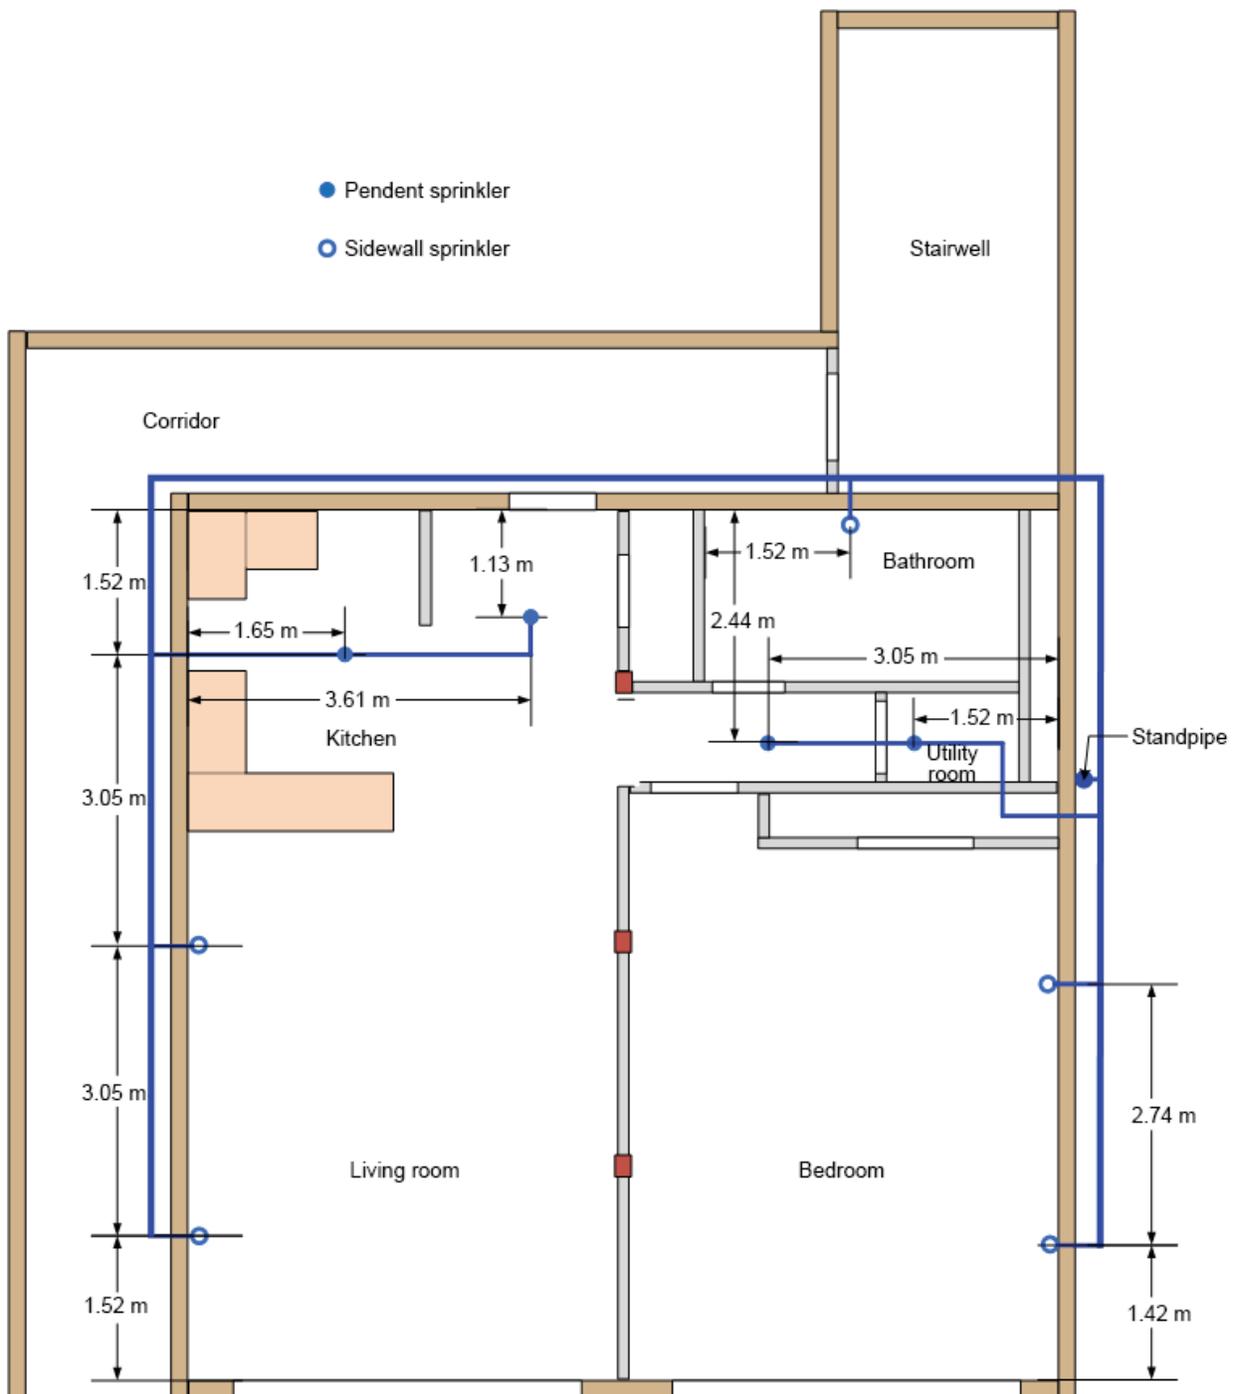
Figure 41. Sprinkler layout.

A fire sprinkler system was installed in the first floor apartment for Tests 4 and 5. The sprinklers were designed in accordance with National Fire Protection Association (NFPA) Standard 13, with a design area density of 2 mm/min (0.05 gpm/ft<sup>2</sup>) (light hazard). This design density is less than that which would be required by code for this type of structure and can be conservatively applied to code-compliant tall mass timber construction. The sprinkler system was designed and installed by DC Fire Protection, LLC (Washington, DC, USA). Figure 41 provides the general layout of the sprinkler heads. Pendent-style sprinkler heads were placed in the interior areas of the apartment (kitchen, hallway, and utility room). Sidewall-type sprinkler heads were installed along the walls in the living room, bedroom, and bathroom. Details of the sprinkler heads are provided in Table 2.

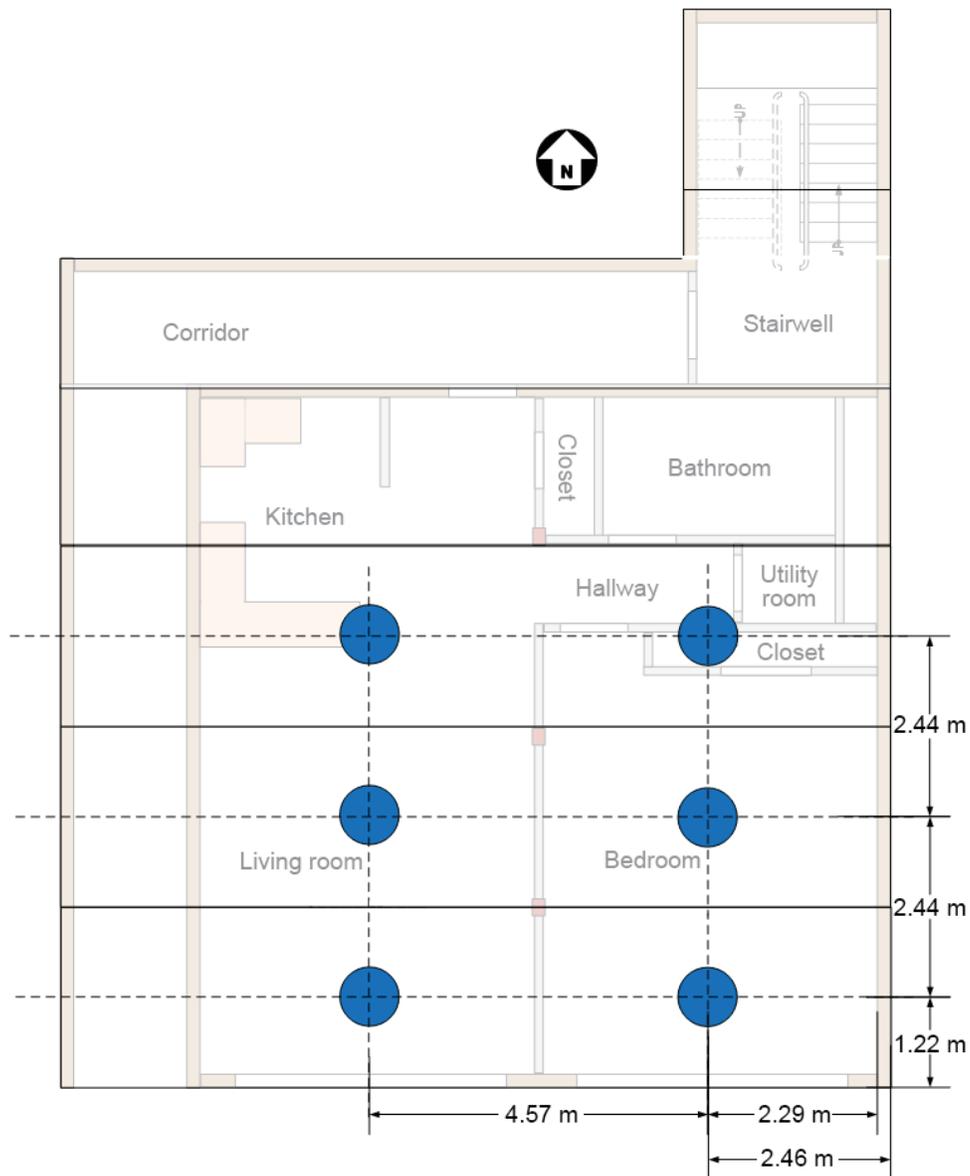
Figure 53. Location of water tanks on the second-level ceiling panel during Tests 2 and 3.

The water tanks were reused for Test 3. However, prior to Test 3, two of the second floor ceiling panels were replaced because they had been partially exposed in Test 2. This required emptying the water from the tanks and moving them out of the way. After replacing the two ceiling panels, the tanks were positioned in their original locations. The day prior to Test 3, each tank was filled with approximately 492 L (130 gallons) of water. Upon arrival the following morning, ATF personnel discovered that one of the water tanks had leaked overnight (Fig. 55). Approximately 378.5 L (100 gallons) of water had leaked onto the ceiling assembly and then down into the structure through the joints between the CLT ceiling panels. A significant amount of water was found in the second level bedroom and living room. A wet vacuum was brought in to remove the standing water on the floor of the second level, and the wetted OSB sheets were replaced. Furthermore, both mattresses in the bedroom were replaced with dry ones that the FRL had on hand. Water stains were also visible on some of the exposed CLT wall panels. The moisture content of the CLT panels was measured using a reference (noncalibrated) moisture meter (Delmhorst J-2000, Delmhorst Instrument Company, Towaco, New Jersey, USA). The moisture content readings measured in the wetted areas of CLT were found to be as high as 27%, compared with 11% to 13% in areas unaffected by the water; however, this reading was most likely only a result of surface wetting as evidenced by the

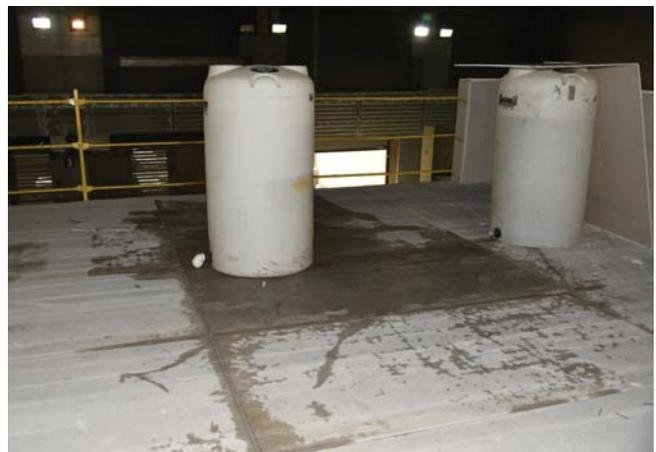
Figure 55. Water tank that leaked.

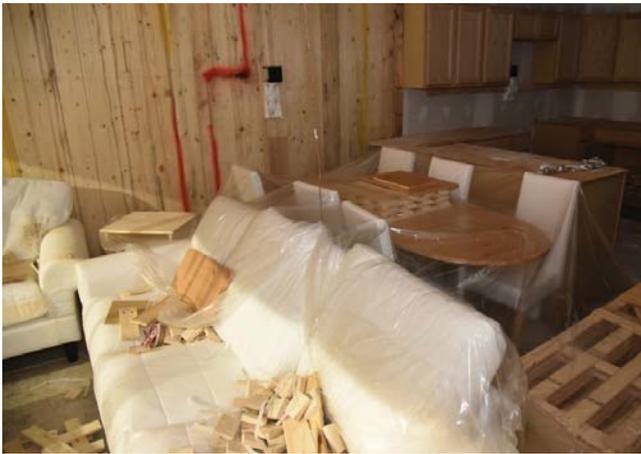
**Figure 56. A plastic sheet placed over furniture during Test 4.**

A sheet of plastic was draped over some of the furniture in the living room to protect it from the water being discharged by the sprinkler head in the kitchen during the test (Fig. 56). The fire never spread beyond the cabinet, so the plastic had no effect on the fire growth.

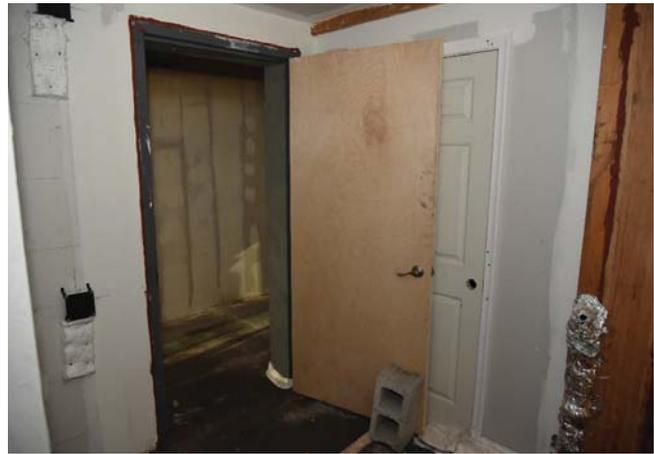
**Figure 57. Apartment door propped open during Test 5.**

Prior to the start of Test 5, a decision was made to keep the apartment door open to allow for additional ventilation to feed fire grown. Therefore, the apartment door was propped open using a cement block (Fig. 57).

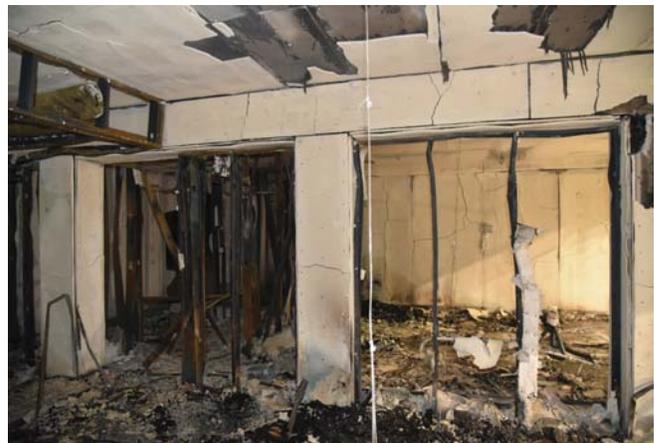
**Figure 58. Interior view of apartment after Test 1.**

Since Tests 2 and 3 were both performed on the second level, restoration of the interior was necessary between Tests 2 and 3. Figures 58 and 59 show the interior of the apartment after Tests 1 and 2, respectively. As part of the restoration, all of the gypsum wallboard was removed and then replaced in certain areas, based on the next test series. In addition, the unrated interior walls and drop ceiling were removed and replaced.

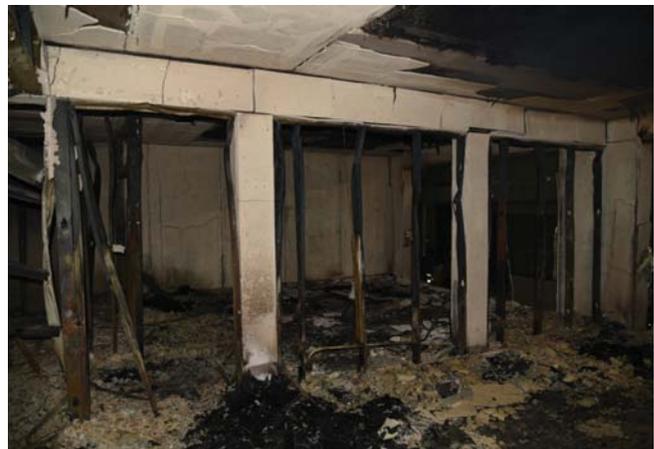
**Figure 59. Interior view of apartment after Test 2.**

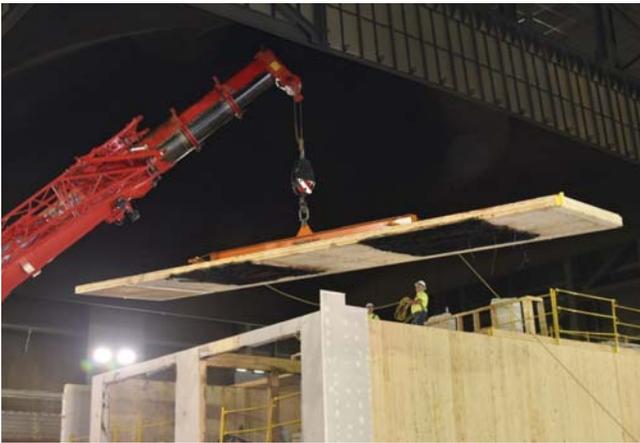
Figure 60. Second-level ceiling panel being removed after Test 2.

As part of the restoration, two of the second floor ceiling panels were also replaced. The ceiling panels were replaced because those two panels were the exposed CLT sections on the ceiling during Test 2. Figure 60 shows one of the ceiling panels as it was being removed.

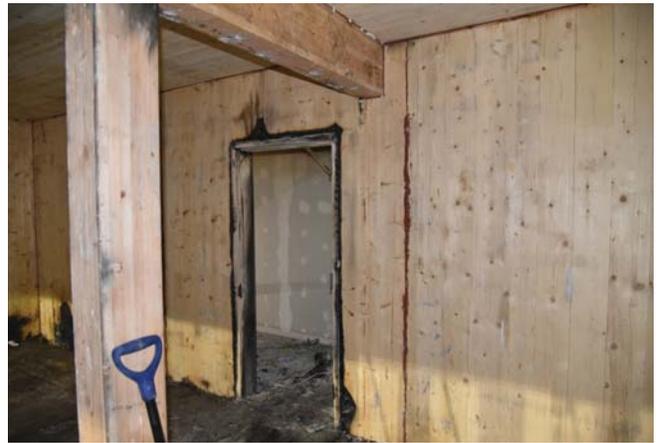
Figure 63. Localized section loss caused by charring around apartment door frame on the second floor.

material. In addition to the opening perimeters in Wall A, localized charring occurred around the apartment door frame during Tests 1, 2, and 3. Figure 63 illustrates some of the charring that occurred around the second-level door frame during Test 2. The damaged areas were removed, and the wall was repaired (Fig. 64).

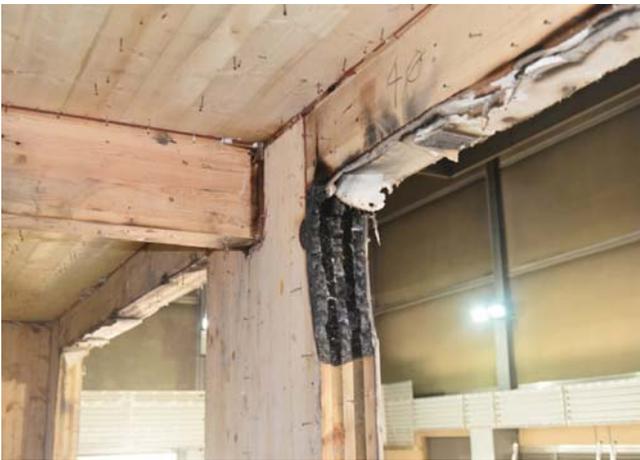
Figure 61. Localized section loss caused by charring on Wall A at the living room opening on the second floor.

The restoration of the test structure also involved repairing sections on the CLT wall assemblies that had sustained fire damage in the form of section loss caused by localized charring. Figure 61 is an example of the localized damage that occurred at the opening on Wall A on the second floor during Test 2. The wall was repaired by removing the damaged section (Fig. 62) and replacing it with equivalent

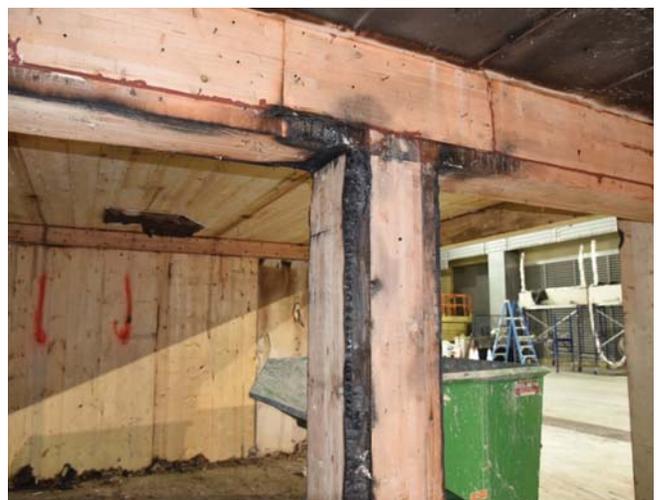
Figure 65. Damage to support column and midspan beam.

Localized charring was also observed on the corners and intersections of support columns and midspan beams. An example of this charring is shown in Figure 65. The damage was limited to the corners and intersections of the wood that was added to the original support columns and beams. These damaged sections were removed and replaced with equivalent wood pieces.

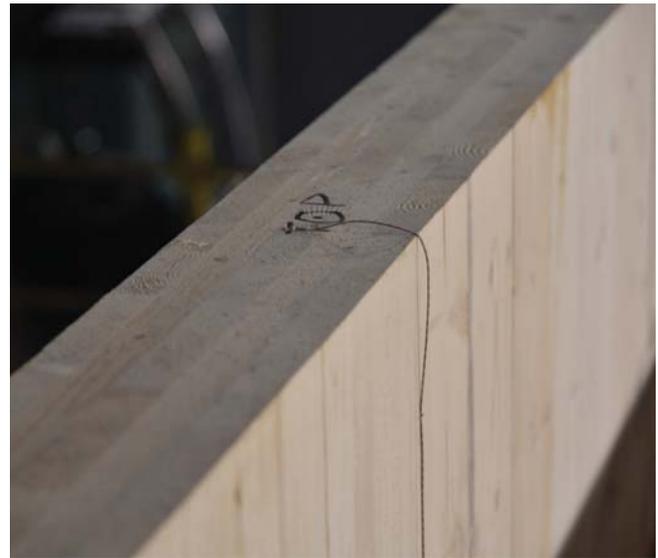
**Figure 76. Thermocouple placed on wall to measure temperature at ceiling–wall joint interface on the second floor.**

Figures 75 and 76 show the location of the joint temperature measurement between the wall assembly and the ceiling assembly. The photograph was taken prior to the ceiling assembly being installed.

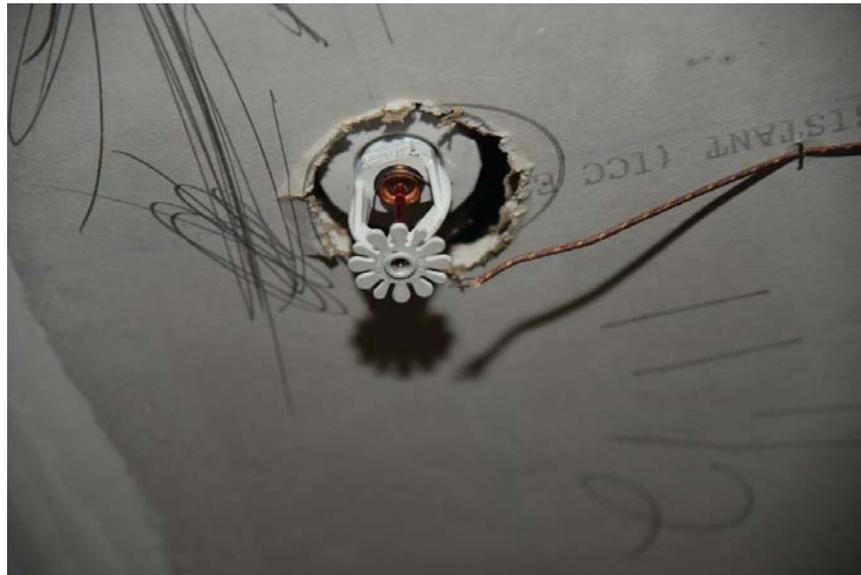
Figure 79. Thermocouple placed near sprinkler head in kitchen for Test 4.

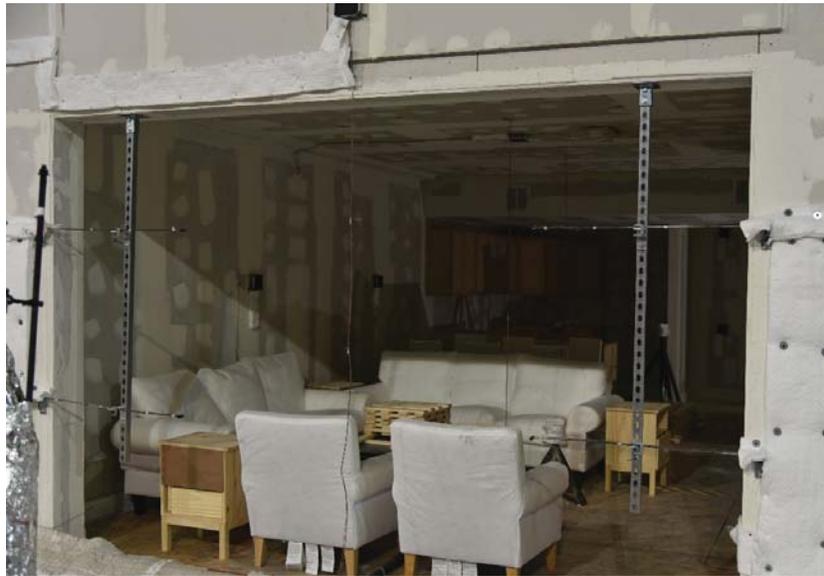
Figure 82. Bidirectional probes mounted at the opening in Wall A.

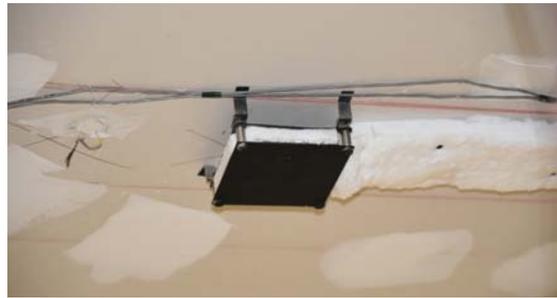
Figure 84. Directional flame thermometer mounted on ceiling.

The DFTs used in this test series were provided by the USDA Forest Service, Forest Products Laboratory (FPL). Figure 84 shows a DFT mounted on the ceiling. Only the temperature data from the DFTs are included in this report.

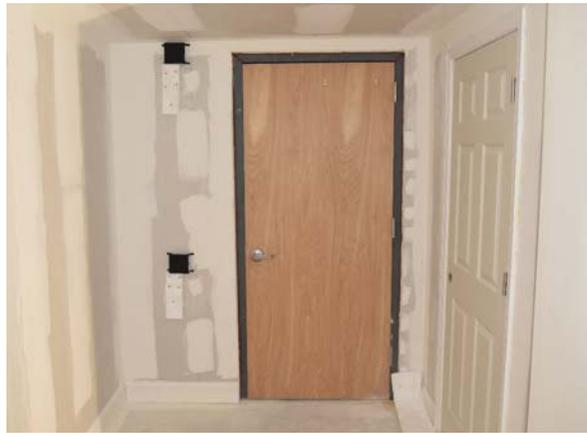
Figure 86. Directional flame thermometers mounted on Wall C near the apartment door.

DFTs were mounted on both the walls and ceiling of the test structure. Figure 85 shows the location of the DFTs on the interior walls. The DFTs located on Walls B and D were mounted 1.52 m (5 ft) above the finished floor. Two DFTs were also mounted next to the apartment door on Wall C (Fig. 86). These DFTs were located 0.914 m (3 ft) and 2.18 m (7 ft 2 in.) above the finished floor.

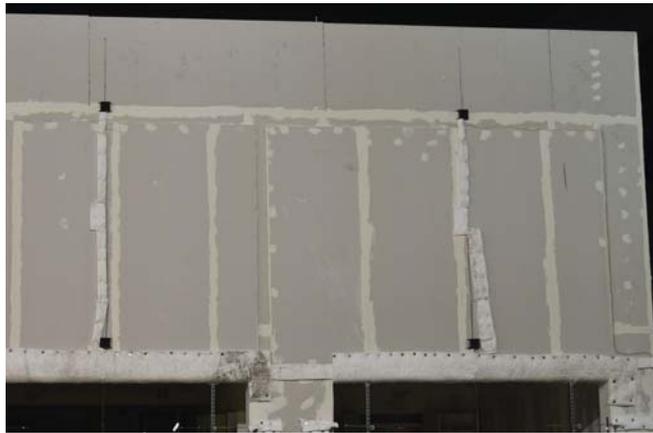
Figure 88. Directional flame thermometers mounted on the exterior of Wall A.

For Test 1, four additional DFTs were mounted on the exterior of Wall A (Fig. 88). The location of each DFT is shown in Figure 89.

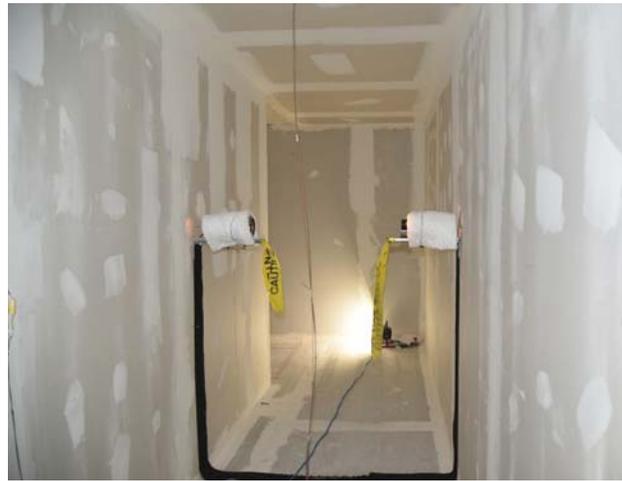
Figure 90. Optical density meters located in the corridor.

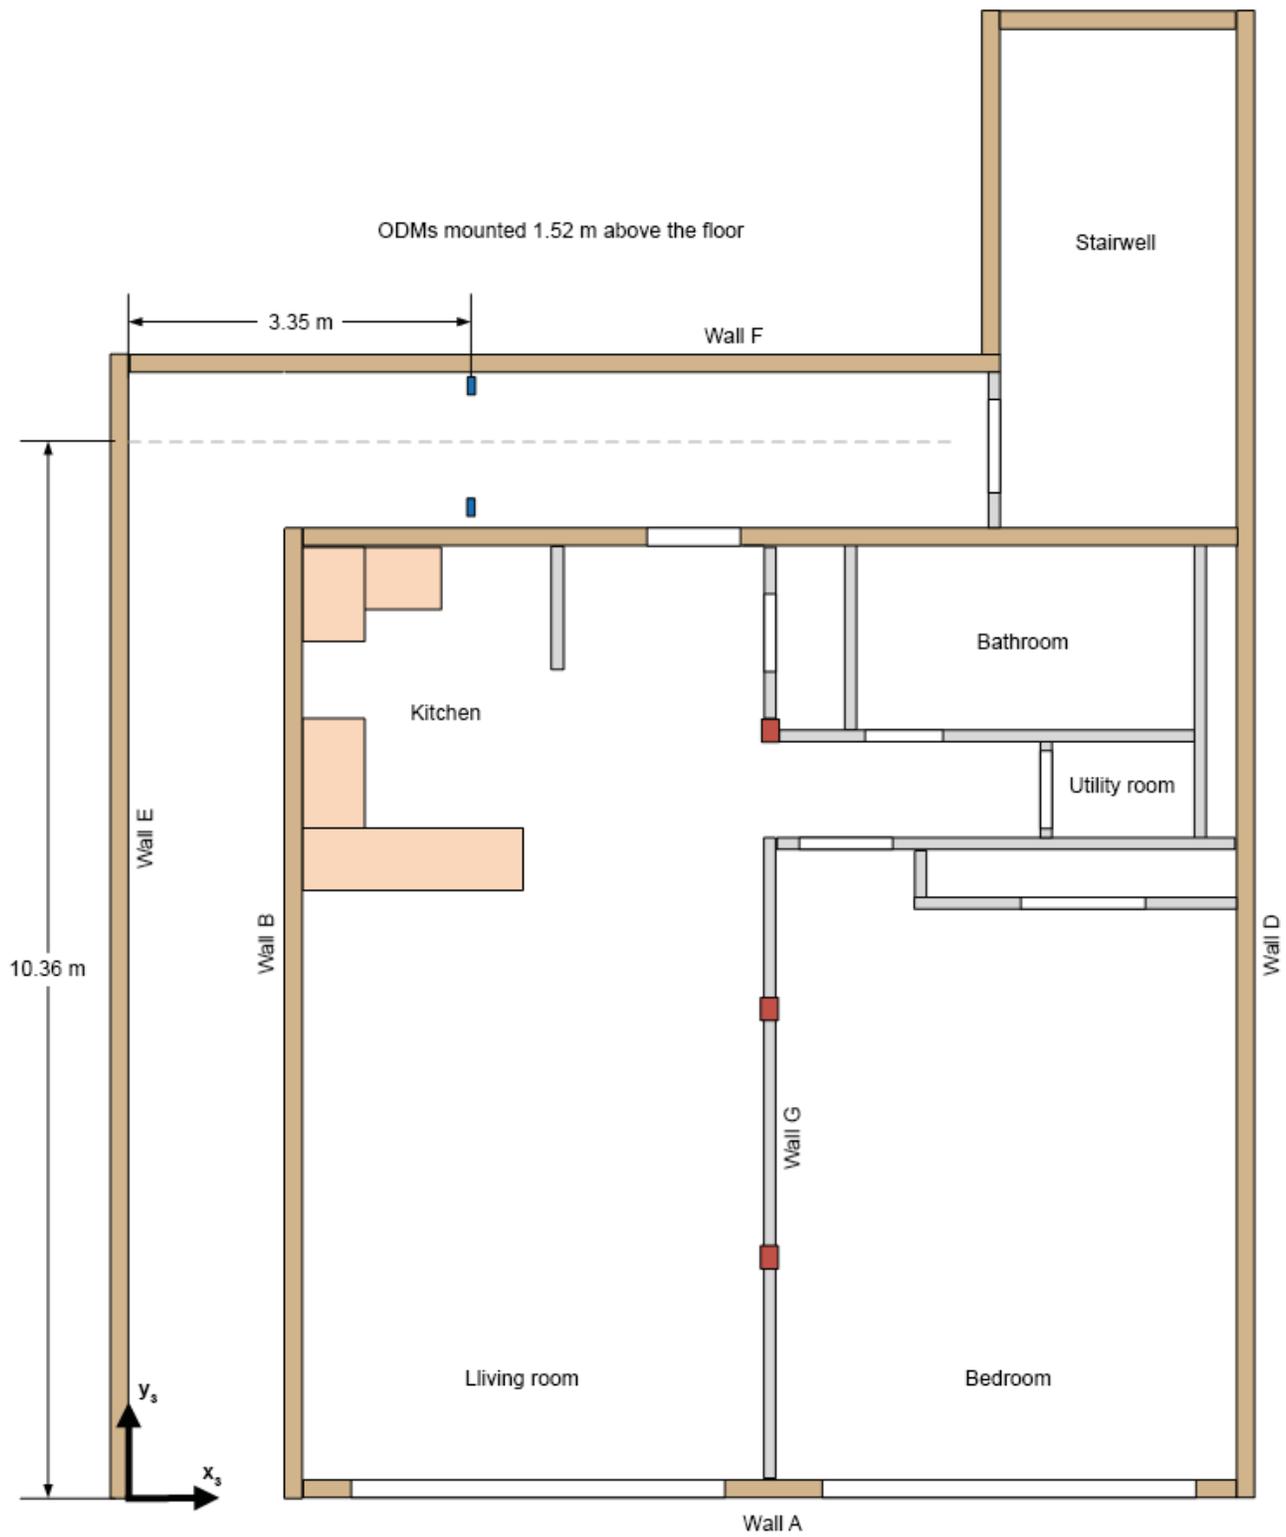
Figure 91. Location of optical density meters (ODMs) (blue rectangles).

ODMs were used to measure the smoke obscuration during the experiments. The ODM consists of two parts: a light source and a photo transducer, which responds to the intensity of light from the light source. The photo transducer produces an output voltage that is linear with the amount of light received from the light source. An increase in intensity of light results in an increase in output voltage, and a decrease in intensity of light results in a decrease in output

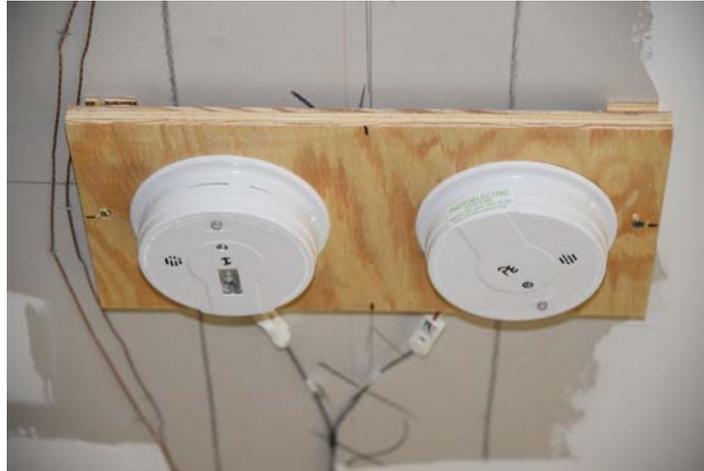
**Figure 92. Smoke detectors.**

Smoke detectors are devices used to activate an alarm in the presence of smoke. Smoke detectors send notifications in the form of audible, visible, and/or electrical responses. For this test series, interconnected-type smoke detectors were selected because detector activation could be determined by monitoring the electrical output produced by each detector. Table 8 provides a description of the smoke detectors used in the experiments. Figure 92 shows the smoke detectors as mounted to the ceiling. At each location, two smoke detectors were used, an ionization smoke detector and a photoelectric smoke detector. Figure 93 shows the location of smoke detectors in the test structure.

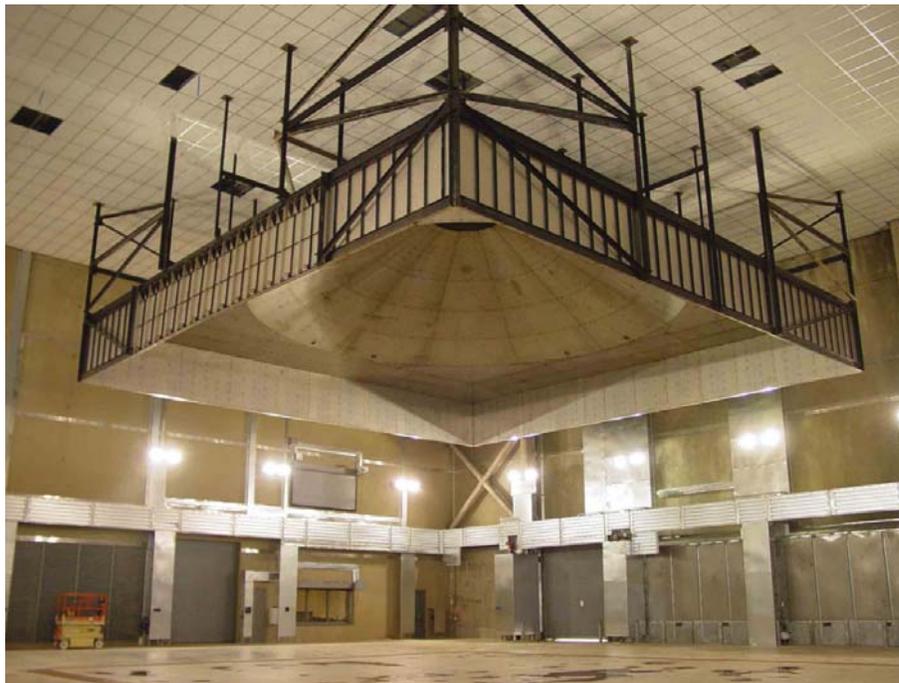
**Figure 96. 14-MW fire product collector at the Bureau of Alcohol, Tobacco, Firearms and Explosives (ATF) Fire Research Laboratory.**

A fire products collector (FPC) measures several characteristics of a fire based on the measured properties of the fire plume. An FPC consists of a collection hood connected to an exhaust duct placed over a fire (Fig. 95). The primary fire characteristics calculated from an FPC include heat release rate (HRR), convective heat release rate (CHRR), gas species production, and smoke production. HRR measurements are based on the principle of oxygen

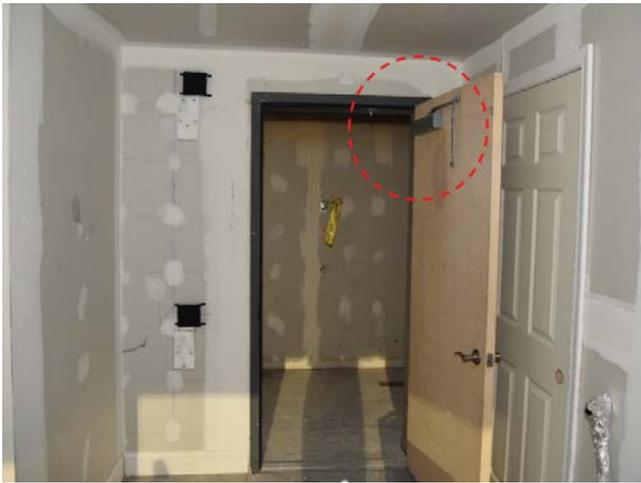
Figure 98. Automatic door closer not attached for Test 3.

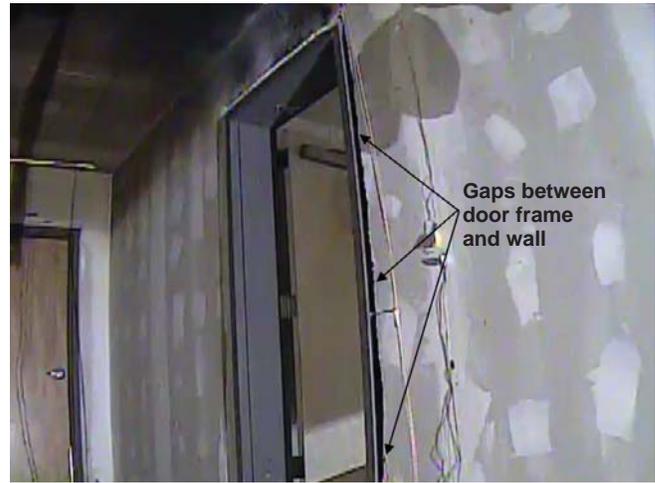
Figure 99. Gaps between door frame and wall.

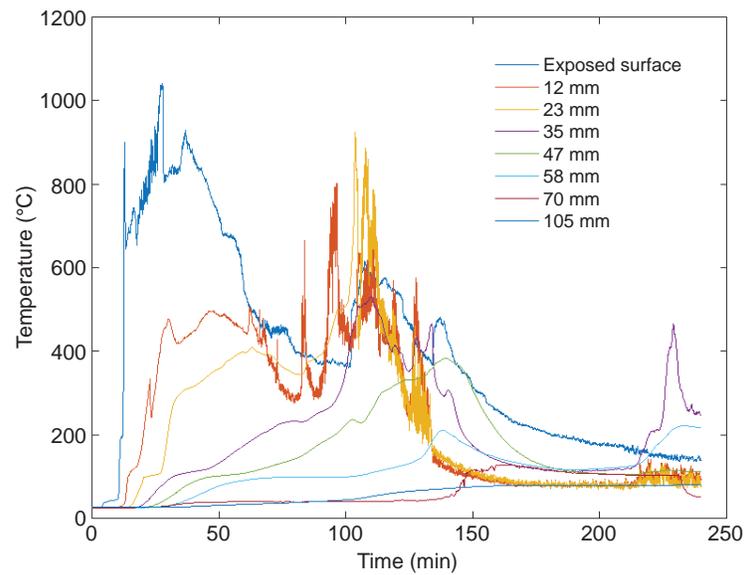
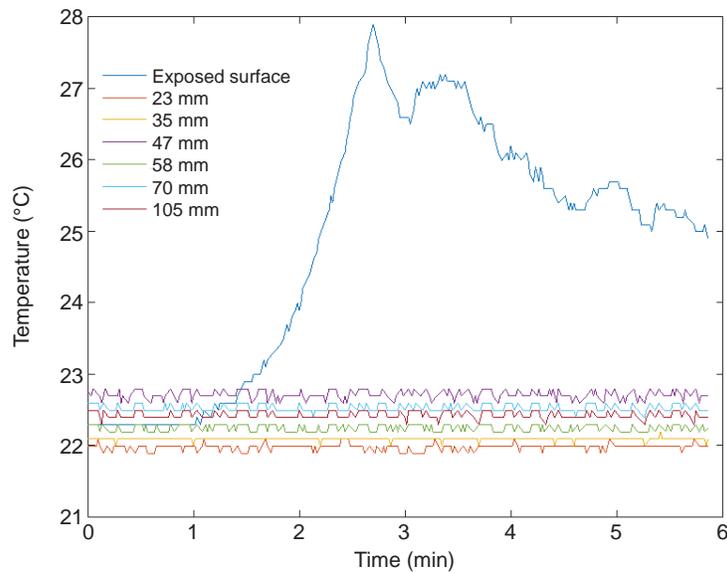
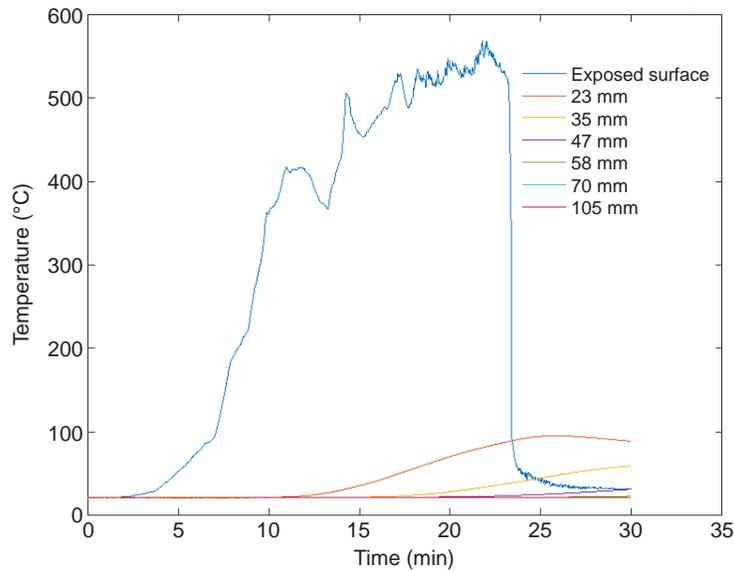
**Figure 106. Embedded thermocouple temperatures in living room wall at location B for Test 3.**

**Figure 107. Embedded thermocouple temperatures in living room wall at Location B for Test 4.**

**Figure 108. Embedded thermocouple temperatures in living room wall at Location B for Test 5.**

Tests 3, 4, and 5 had exposed CLT on Wall B near the living room–dining area. The embedded thermocouple temperatures for these tests at Location B are provided in Figures 106 to 108. For Test 3, the surface temperature began to increase again around 100 min. Additionally, embedded thermocouple temperatures increased around the same time, with some noise occurring for the thermocouple at 12 mm (0.47 in.). This increase and noise were caused by localized delamination of the first layer of CLT near Location B.
