The Triangle Shirtwaist Fire: Difficult Lessons Learned on Fire Codes and Safety

By Stephen D. Jones, C.B.O.

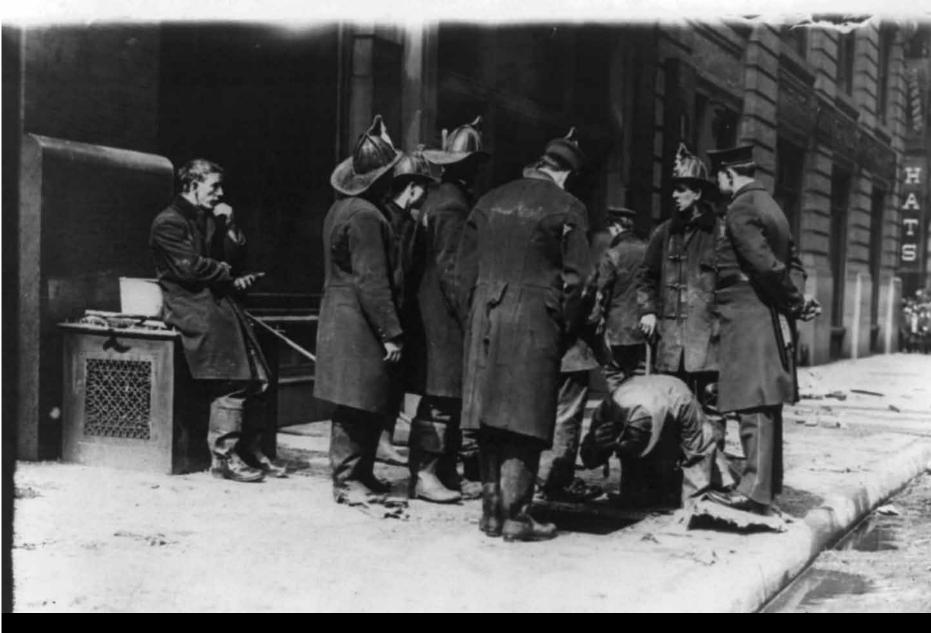
Firemen search for bodies in the aftermath of the Triangle Shirtwaist fire.

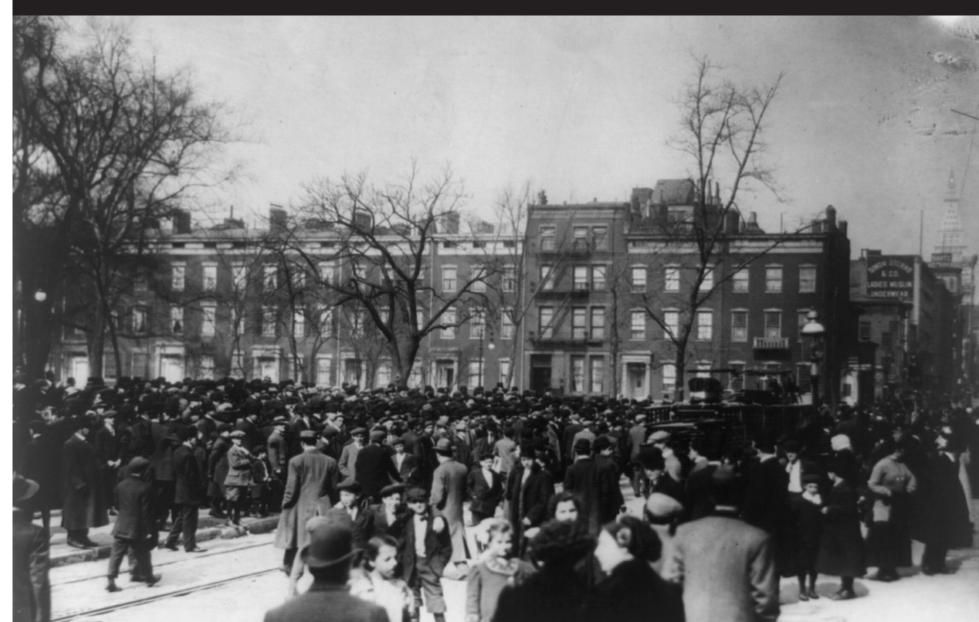
People watch helplessly on the Washington Place side of the street during the Triangle Shirtwaist fire in the Asch Building in New York City.

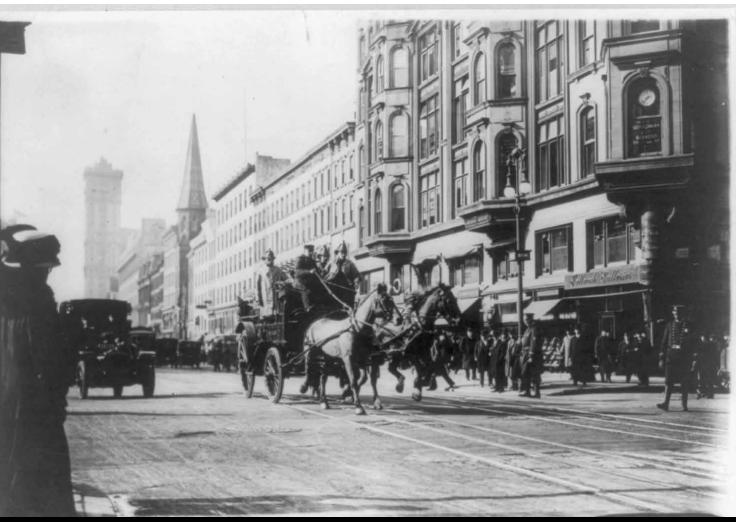
Horse-drawn fire engines in the street on their way to the Triangle Shirtwaist fire in New York City.

New York City's fire department apparatus, touted to be the finest in the country, had not kept pace with the burgeoning construction industry at that time; its manual ladders could only reach to the sixth floor, fully two floors below the level of fire. Use of ground hoses proved ineffective and rescue operations were virtually non-existent. Attempts at stretching fire nets to stop or catch jumpers were thwarted when groups of women opted to jump hand-in-hand, tearing the nets. No one survived the nine-story plunge to a net being held, at best, six feet off the ground. Once the nets became unusable, reports were that people and debris falling or jumping from the building and landing on the hoses or injuring the horses hampered further fire department efforts. Fire equipment had to be pulled back from the scene to prevent further losses.

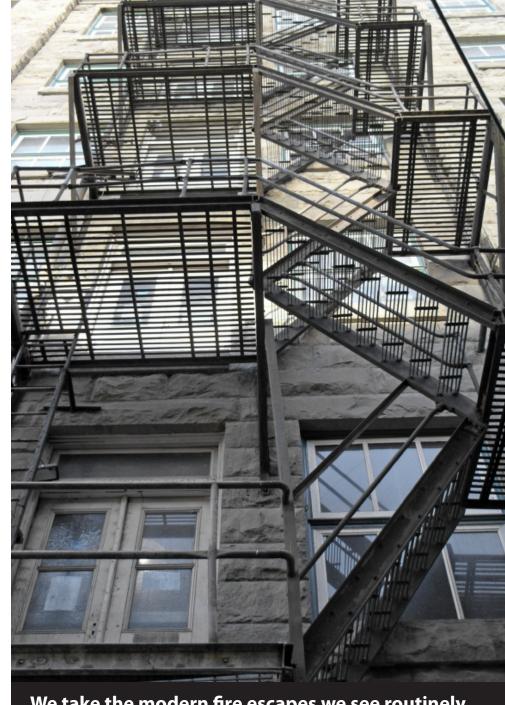
We take the modern fire escapes we see routinely, such as this one, for granted. The fire escape tacked on to the rear of the Asch Building had nearly vertical angled steps and, more frightening, they did not go all the way to the ground.

The fire escape, which measured 16- by 18-inches wide, was tacked on to the rear of the building to satisfy the minimum requirement in the building code at the time. The nearly vertical angle of the ladders made descent all but impossible for women in dresses. More frightening was the fact that the fire escape did not go all the way to the ground. As installed, the fire escape terminated on top of the skylight that provided light to the basement, a fact that was found out by many too late. Overloaded, the fire escape collapsed, send-

ing scores to their death. The one thing that could have saved lives actually cost many more.
