# POST-EARTHQUAKE FIRES: THE TICKING TIME BOMB

by Mark Kluver, P.E.

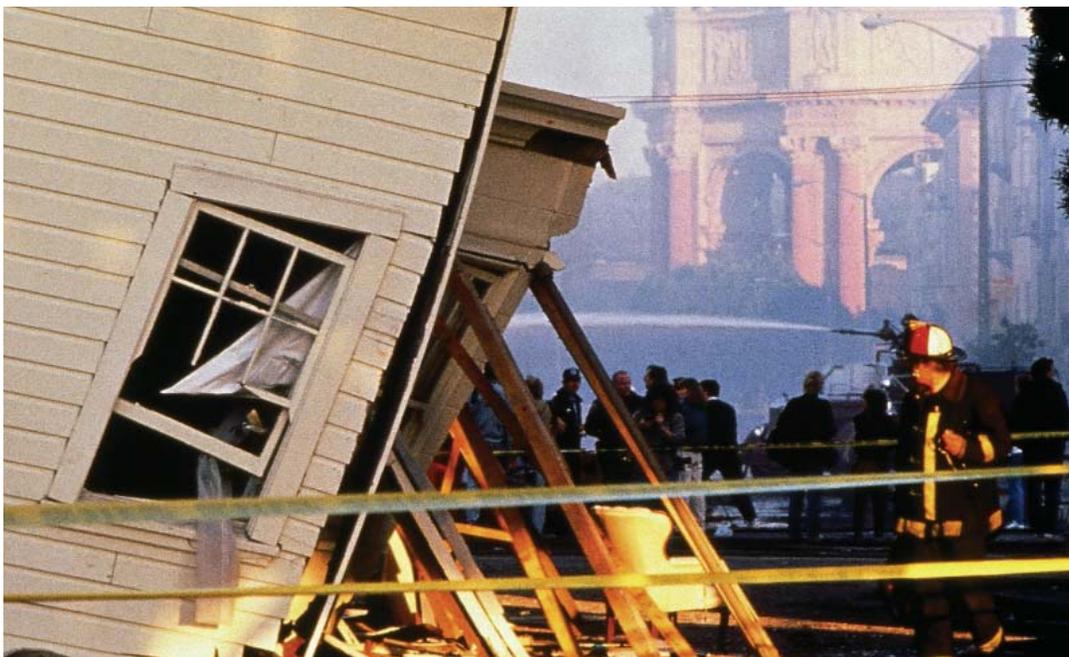
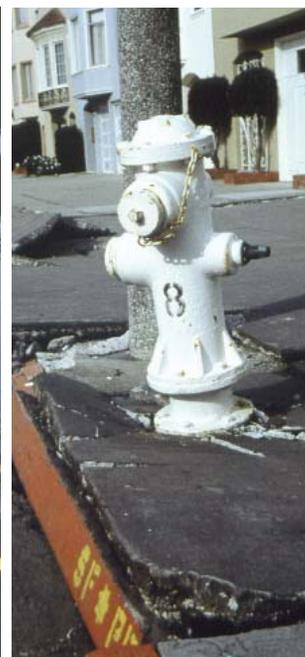
Although the epicenter of the 1989 Loma Prieta Earthquake was 60 miles from San Francisco, it caused 26 fires including one in the city’s Marina District that threatened to become a major conflagration. (Photos courtesy of the San Francisco Department of Building Inspection and Mark Kluver.)

The October 17, 1989, the Loma Prieta earthquake occurred on the San Andreas Fault in the Santa Cruz Mountains of California. Measuring 7.1 on the Richter scale, the temblor was of only moderate force compared to what is possible along that portion of the fault line. Even so, it was responsible for 26 fires in San Francisco, located more than 60 miles from the epicenter. One fire in the Marina District spread to several buildings despite the availability of two auxiliary water systems devoted specifically for firefighting, an extensive system of water storage cisterns and a fireboat—precautionary lifelines put in place in response to the devastating fire losses following the city’s historic 1906 earthquake. The crux of the problem was some 67 breaks in water mains, which effectively eliminated water pressure in

the area. Fortunately, the fire was contained thanks to the fireboat and the availability of 6,000 feet of hose to draft water from the bay.

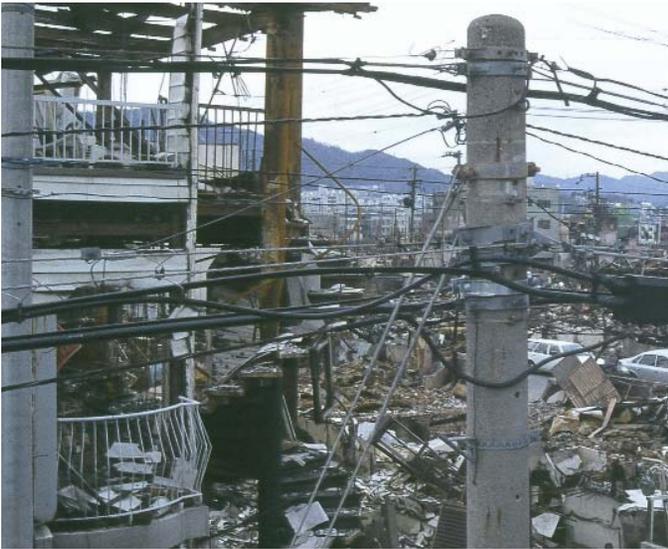
Ruins of homes and businesses in Kobe, Japan, after experiencing three days of conflagration-size fires. (Photo by Mark Kluver.)

On January 17, 1995, an earthquake of similar intensity struck near Kobe, Japan. Approximately 90 fires broke out within minutes, primarily in the densely built-up areas of low-rise, mixed residential commercial buildings in the central city. At least 85 of these fires spread to adjacent buildings and 10 were considered “super” in size (either approaching or reaching conflagration status). The Kobe water system sustained more than 1,700 breaks, cutting off water for firefighting within a couple of hours following the quake. Collapsed buildings and excessive traffic congestion further stymied firefighters’ efforts. Subsequent research conducted at Kobe University indicates that 500 deaths were due to fire and that almost 7,000 buildings were destroyed by fire alone.

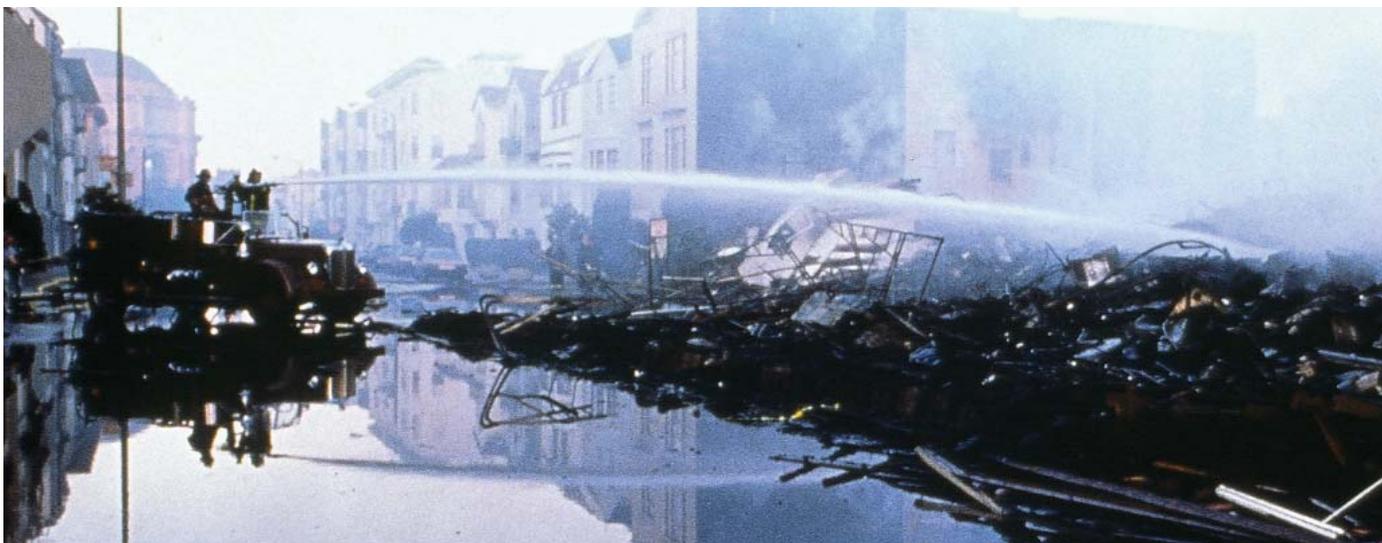
After the domestic and two separate underground fire service water systems experienced loss of pressure due to pipe damage, water had to be drafted from the San Francisco Bay by a fireboat to bring the 1989 Marina fire under control. (Photo by Mark Kluver.)
