### A Six-Inch Mountain to Climb: Curb Ramp Problems, Concerns and Solutions

Kimberly Paarlberg, RA, ICC Senior Staff Architect

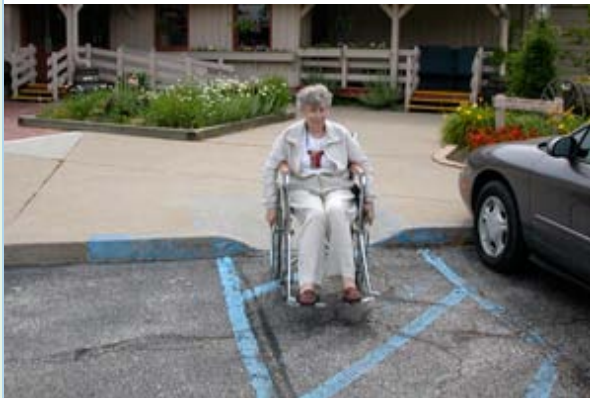
Key to making the route between an accessible parking lot and an accessible entrance accessible is design of the rise between the parking lot and the sidewalk.

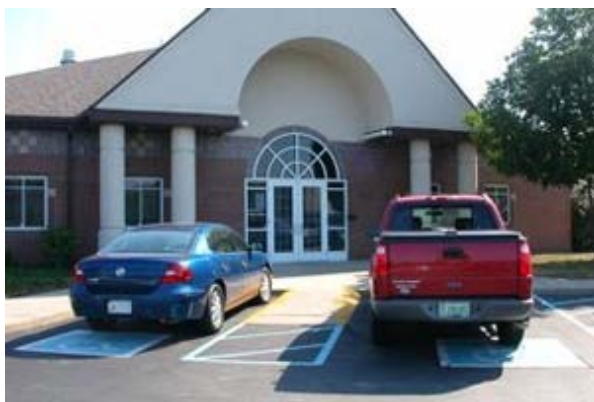
Figure 2: A built-up curb cut ramp overlapping access aisles.

##### *A built-up curb cut located in the parking access aisle (Figure 2).*

The access aisle for an accessible parking space is required to be level for the entire length of the parking space (ICC A117.1 502.5). A built-up curb ramp extending

into the access aisle creates a sloped surface that can make transfers from the vehicle to a mobility device difficult if not impossible. In addition, some transfer vans have deployment ramps that sense for level surfaces when they touch the ground. If the surface is not level, they will return to the closed position. If a built-up curb ramp is necessary to be able to get a landing at the top and bottom, it must be located on a route outside of the parking access aisles.

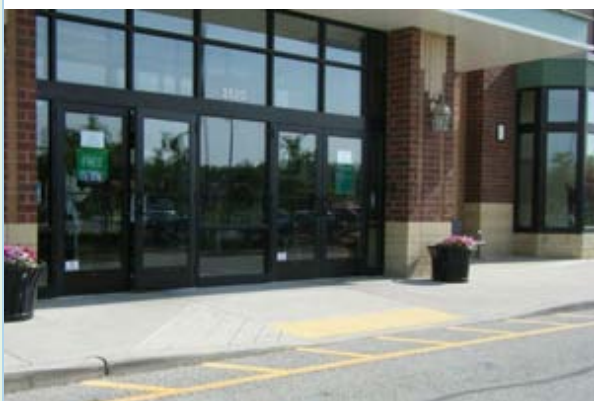
Figure 1: Example of a curb cut that has no top landing and is in a bad location for access to the entrance.

##### *A curb cut that is the same*

##### *width as the sidewalk (Figure 1).*

While the 1998 ICC A117.1 permitted this, and the 2003 ICC A117.1 permits it on existing sites being altered, it is not permitted in new construction (ICC A117.1 406.7). In new construction, a 36-inch-deep-minimum landing at the top of a curb ramp is required. Without it, a problem occurs when a pedestrian route is perpendicular and across the curb cut. The cut-in does not have a level route past the top of the ramp, and persons moving across the ramp have to deal with multiple slopes in changing directions. This is a tripping hazard for persons with mobility impairments. This type of curb cut is also difficult for a person using a wheelchair when they have to deal with the alternating slopes of the ramp surface and flared sides as they move up the curb cut at an angle.

### ***Curb ramps in bad locations*** (Figure 1).

Don't locate a curb cut or curb ramp, including any flared sides, so that it can be blocked by parked cars (ICC A117.1 406.6). Even if constructed correctly, if you cannot get to it, it doesn't work. Also, locate the curb ramp along the logical and common route between the accessible parking spaces and the accessible entrances (2009 IBC 1104.5 and 1106.6). A person using a mobility device must be able to move along with the general population

to the accessible entrance. This may not be the most direct line. One example is a route that leads to a marked crosswalk rather than cutting diagonally across a vehicular route. Also, remember that when curb ramps are at marked crossings, the crossing should include the ramp and the flared sides (ICC A117.1 406.6).

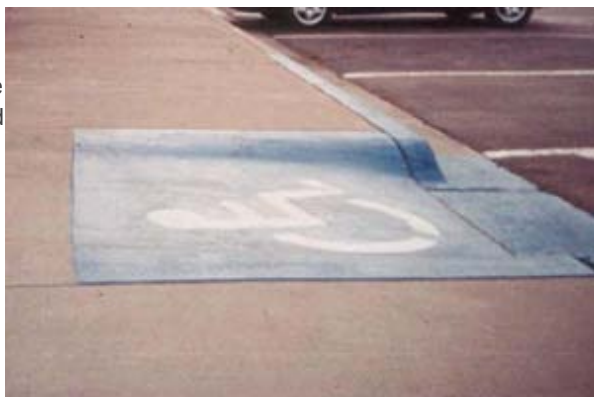
Figure 3: Curb cuts with side curbs and painted surface pose a possible tripping hazard.

#### ***Possible tripping hazards*** (Figure 3).

When there is space for a route past the top of a curb cut, flared sides are not required. However, this can be a tripping hazard in situations where the sidewalk is so crowded that the entire width is occupied or where the curb cut location might not be obvious to persons with vision impairments. A site designer could choose to provide flared sides, but they must have a maximum slope of 1:10.

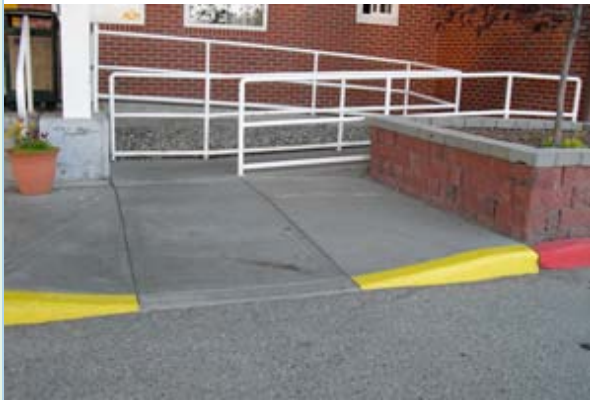
Figure 4: Example of the new painted curb requirements

The 2010 ICC A117.1 has added a new requirement for the sides of curb ramps when the curbs along the street or parking lot are painted. The purpose is to provide a visual clue for person with sight impairments. This version of the standard requires that the curb portion along the flared sides also be painted, but not the curb portion at the ramp itself (see Figure 4). It is important not to paint the flared sides of the curb ramps or the ramp surface itself.

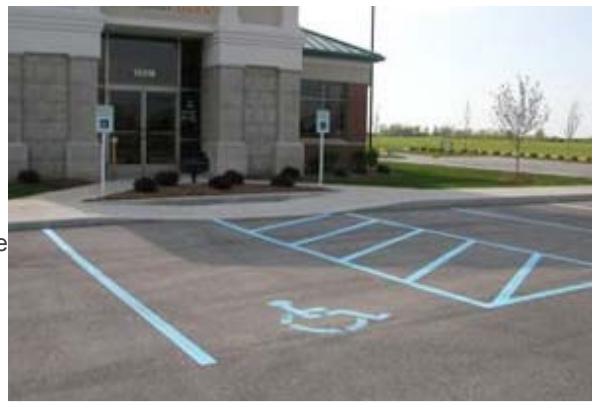
Figure 5: Curb solution with depressed sidewalk

A possible solution for sites where a 36-inch wide sidewalk is preferred would be to depress a section of the sidewalk to the level of the parking lot. A curb ramp at both ends of the route would be a straight slope, thus eliminating the need to either go around or negotiate over sloped sides. The minimum recommended length of the bottom landing would be 60

inches, so that a person using a wheelchair could move to the front of the curb ramp on a flat surface (Figure 5). Since this is the width of the access aisle, that should not be a problem. The sidewalk could even be depressed along the entire width of several accessible spaces. This would allow multiple access points, thus greatly reducing the chance that the route would be blocked. Other options might be not having curbs (Figure 6) or locating the curb ramp away from the building edge (Figure 7). To see
